Mounting info	Spare part kit 8 (SP8)

Machines	Vario Combi Profi / Vario smart Combi 50Hz	
	Date	June 17th, 2016	
Page 1 out of 12	Topic	Servicing

Spare part kit 8 (ET8)

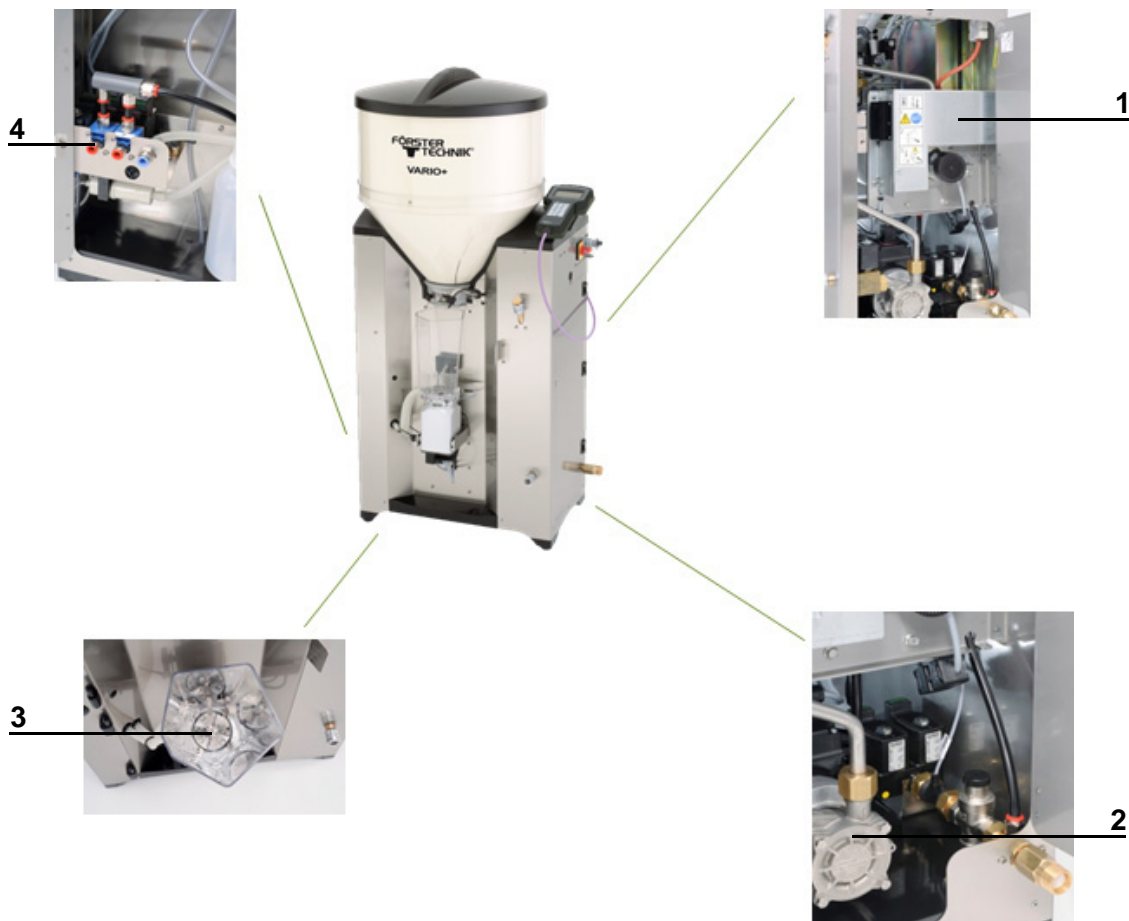
Heat exchanger, milk/water supply, intensive mixer and valves

1. Heat exchanger
2. Water supply
3. Intensive mixer
4. Valves
